Lighted Medical Annunciator/Switch Assembly Service Bulletin 1

Medical annunciator/switch NVIS filtration procedure update.

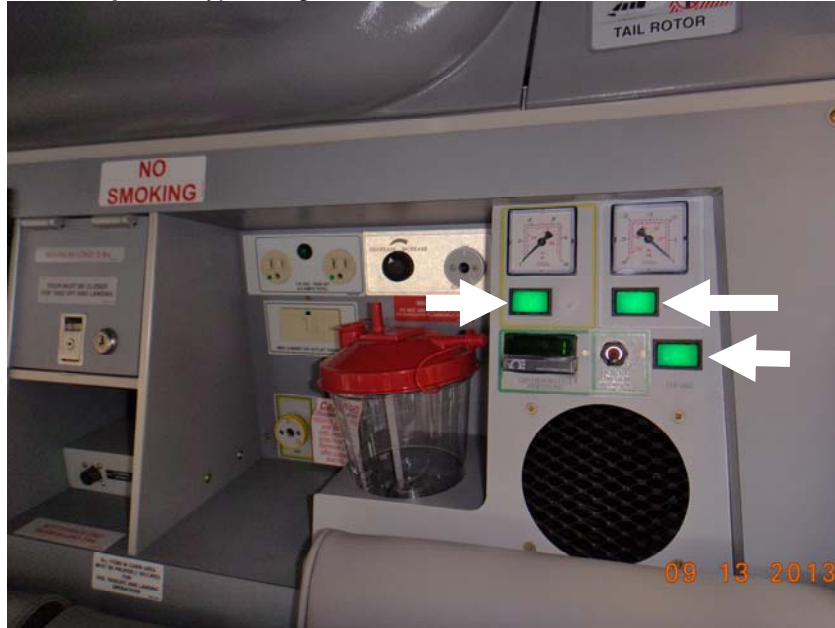
Example 1: Typical Lighted Medical Annunciator/Switch installation.

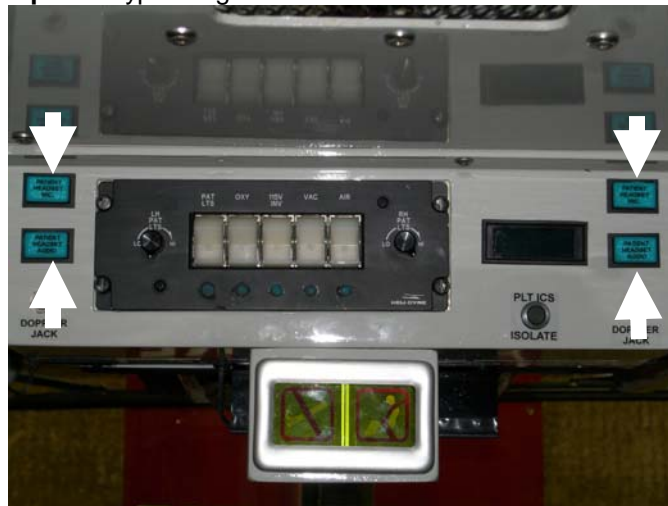
Example 2: Typical Lighted Medical Annunciator/Switch installation.
